National Dam Inspection Program,
PA-RC & D-105 DAM

Basin, Thomas Creek, Susquehanna County,
Pennsylvania. PHASE I INSPECTION REPORT,

NAME OF DAM: PA-RC&D-105 Dam
STATE LOCATED: Pennsylvania
COUNTY LOCATED: Susquehanna
STREAM: Thomas Creek, a secondary tributary of the Susquehanna River
SIZE CLASSIFICATION: Small
HAZARD CLASSIFICATION: High
OWNER: Susquehanna County Commissioners
DATE OF INSPECTION: November 13, 1980 and February 5, 1981

PA-RC&D-105 DAM
ND1 I.D. PA-0979
DER I.D. 058-138
NOVEMBER 13, 1980

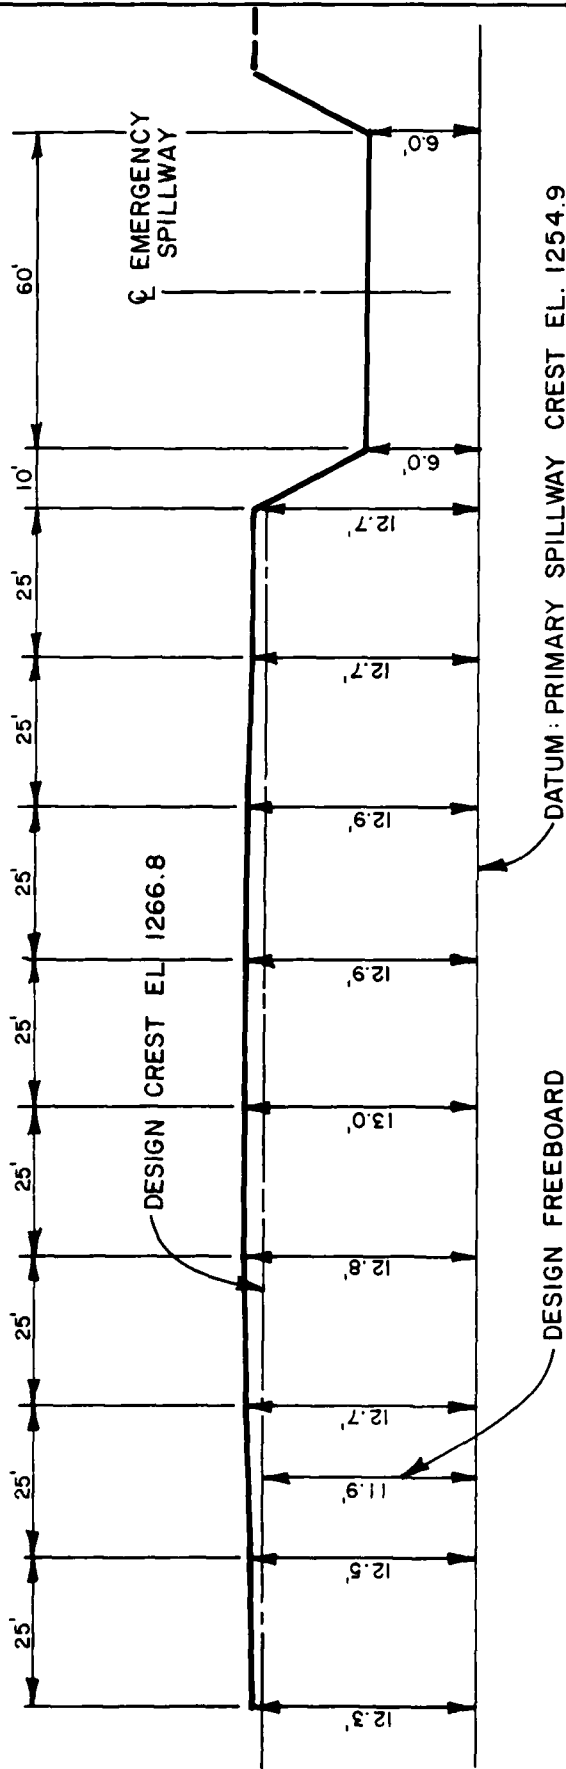
DAM CREST PROFILE (LOOKING DOWNSTREAM)

The top of the dam was surveyed relative to the emergency spillway crest elevation and was found to be within 0.2 foot of the design elevation with camber. Plate 11 shows the dam crest profile.

DAM CREST AT DATE OF INSPECTION
WATER LEVEL ~4" BELOW ORIFICE.
